Goal:  
enable USB OTG/  
USB Host

## PinePhone 1.2 VCONN Hardware Fix

This page details a hardware fix for an issue that was found on early PinePhone hardware revisions (see [PinePhone#Hardware revisions](#) for an overview of the different revisions) and has been fixed since the 1.2a hardware revision.

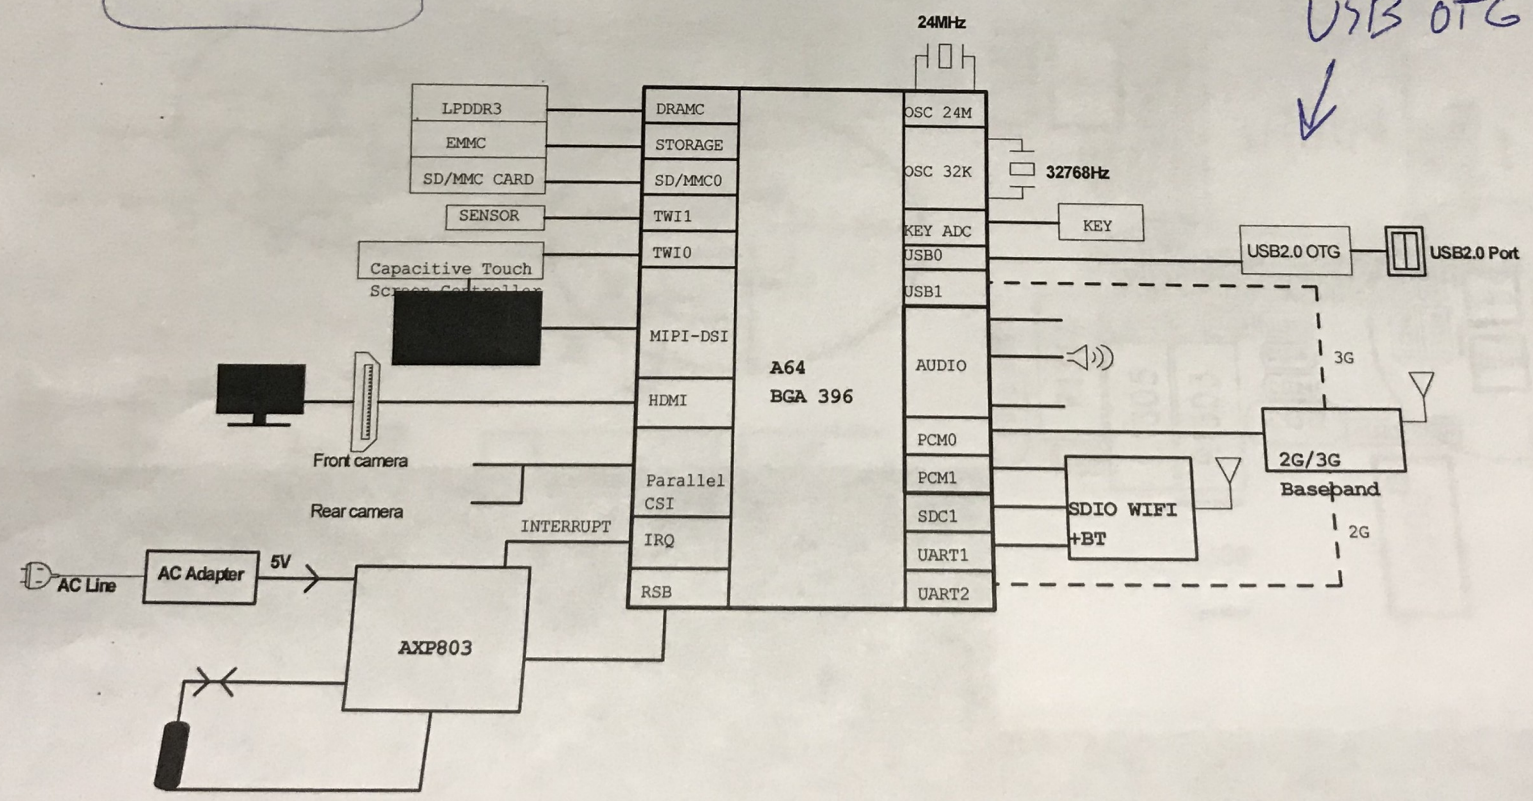
U1305, U1309

Excerpt from the PinePhone schematic showing the two components.

HW fix is to replace AW3512 with a variant of the chip that preserves the EN signal polarity and that doesn't have the "quick discharge function" that ties the output to the GND via a 75 Ohm resistor when the switch is OFF. mozzwald used NCP334FCT2G as a replacement. PCBA revision 1.2a onwards incorporate that fix.
